Manhole Inspection Summary

Manhole # S19GG2001MH

Location Address: **5001 FALLS RD** Cross Street: **BELLEMORE RD**

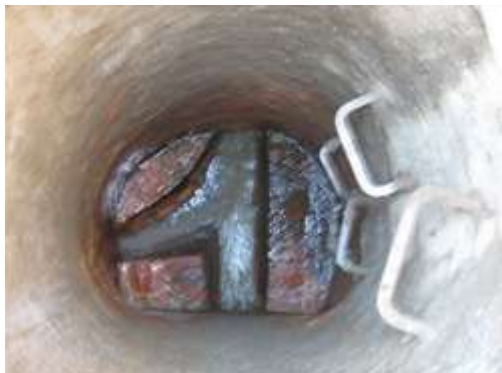
Top View

Corroded steps. Evidence of surcharge - Bench debris.

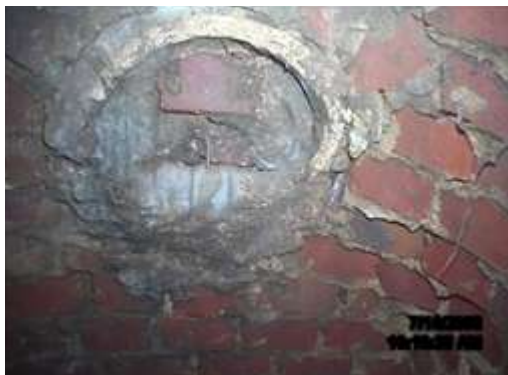
Abandoned pipe

Maybe an old overflow.

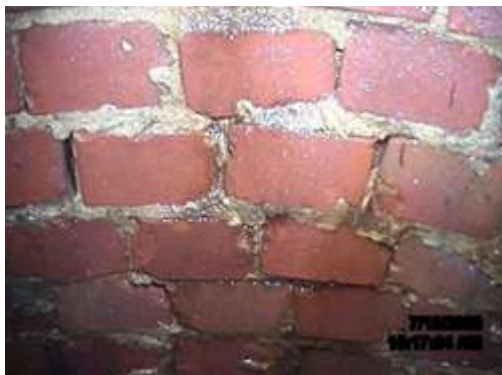
Defect

Barrel deterioration and infiltration (Active).

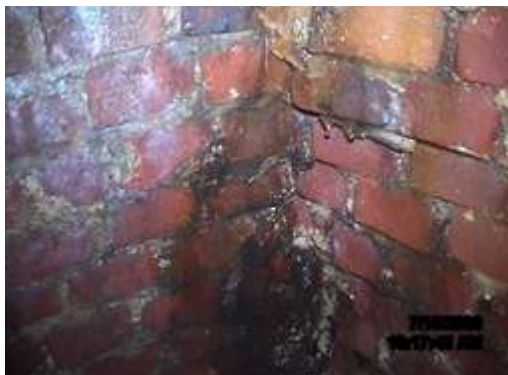
Defect

Barrel infiltration (Active).

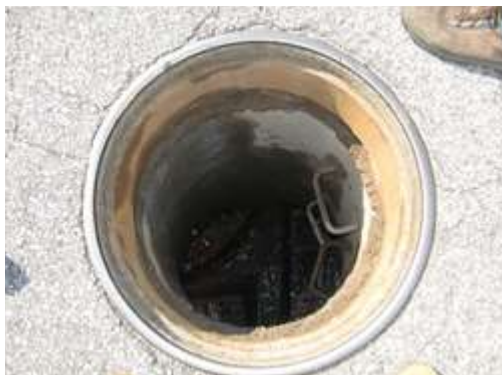
Defect

Frame leaks. Frame offset. Adjustment deterioration and infiltration. Corbel and Barrel infiltration.

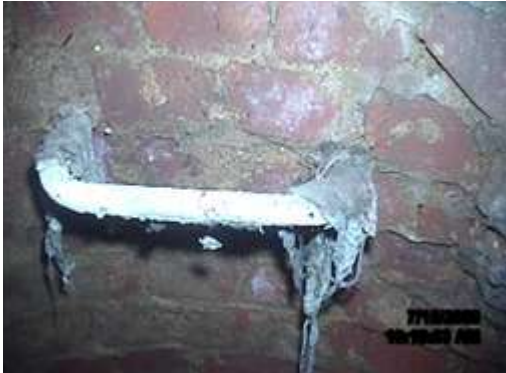
Defect

Evidence of surcharge.

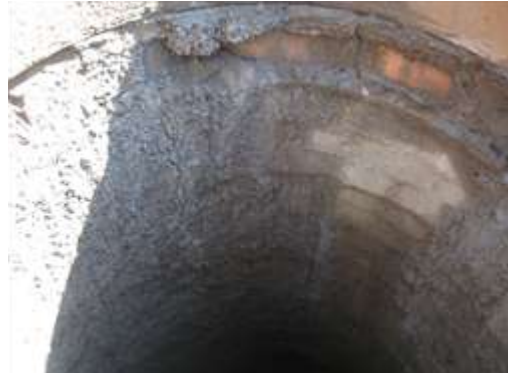
Defect

Frame leaks. Adjustment deterioration and infiltration.

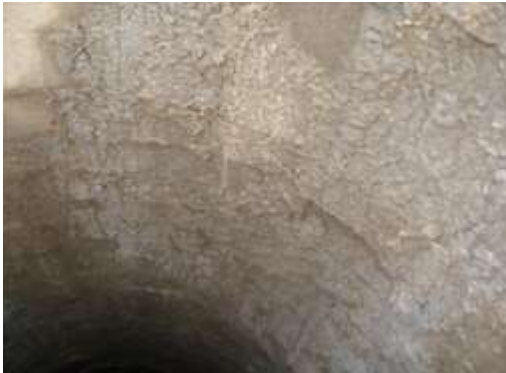
Defect

Frame leaks. Adjustment infiltration.

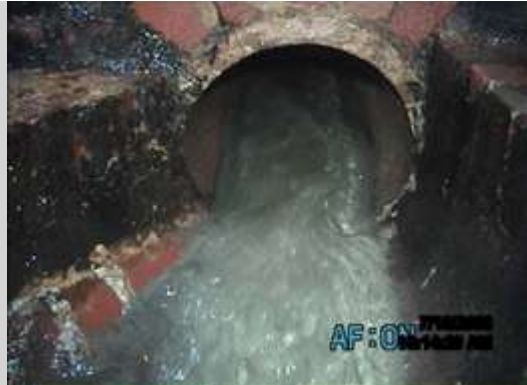
12 in. Circular Gravity Sewer Pipe Out @ 12 O'Clock

Infiltration: **Evidence** Pipe Seal Cond: **Unknown**

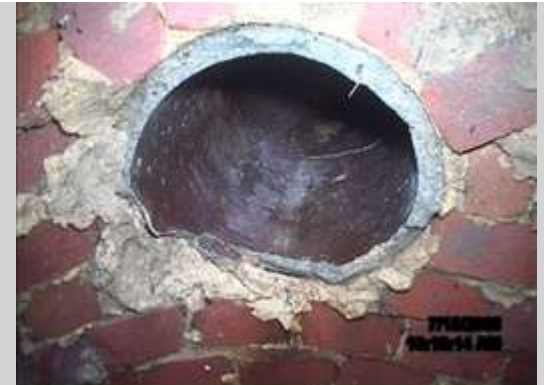
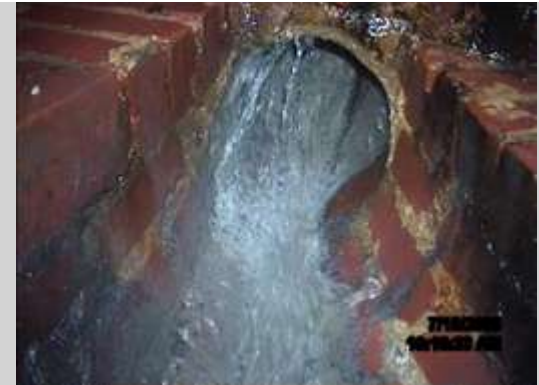
Pipe In @ 9 O'Clock

Infiltration: **Runner** Pipe Seal Cond: **Cracked**
